# Geotechnical Investigation

## Aloravita – Phases 3 and 4

67th Avenue and Jomax Road  
Peoria, Arizona  
ProTeX Job No.: 9821

Report Prepared for: Shea Homes and the Arizona State Land Department

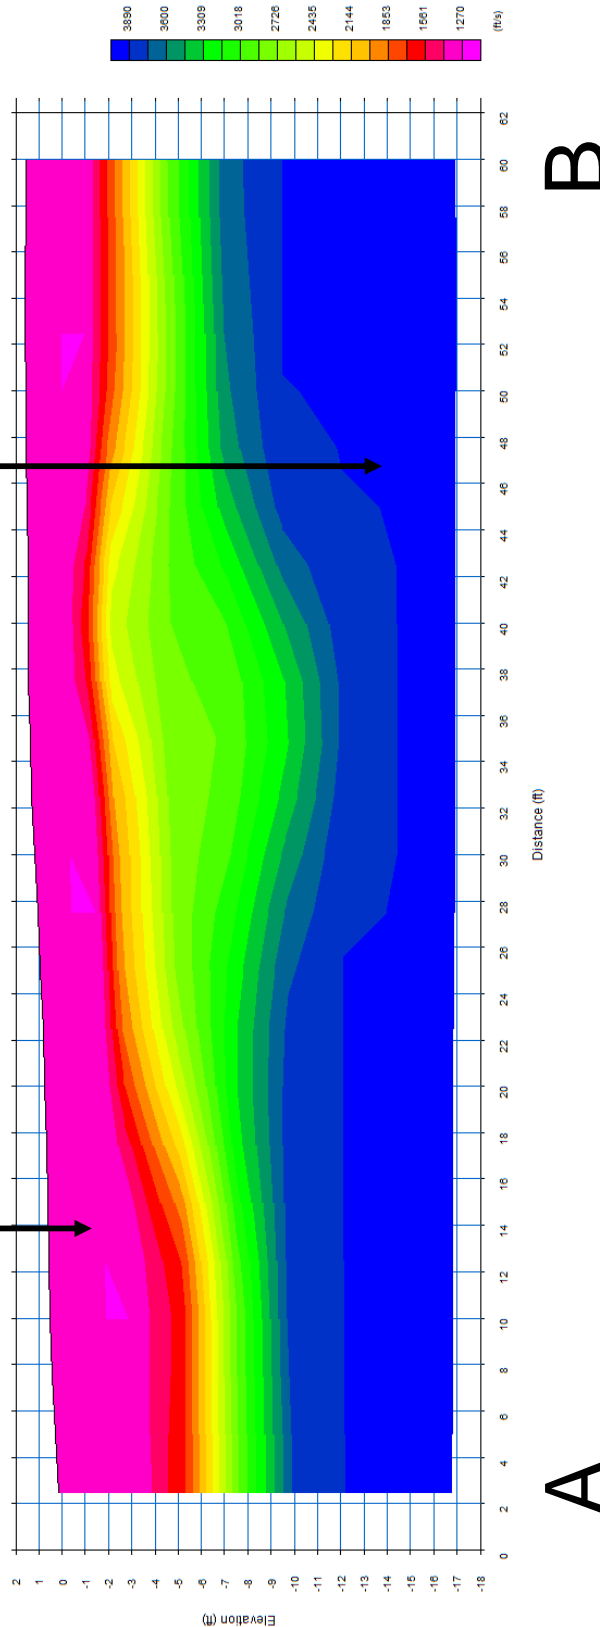
## Seismic Line #14

**Layer 1**  
 Surficial Layer of Silty Sand and  
 Clayey Sand Soils with Varying  
 Amounts of Gravel  
 Vp = 1000 - 2500 fps

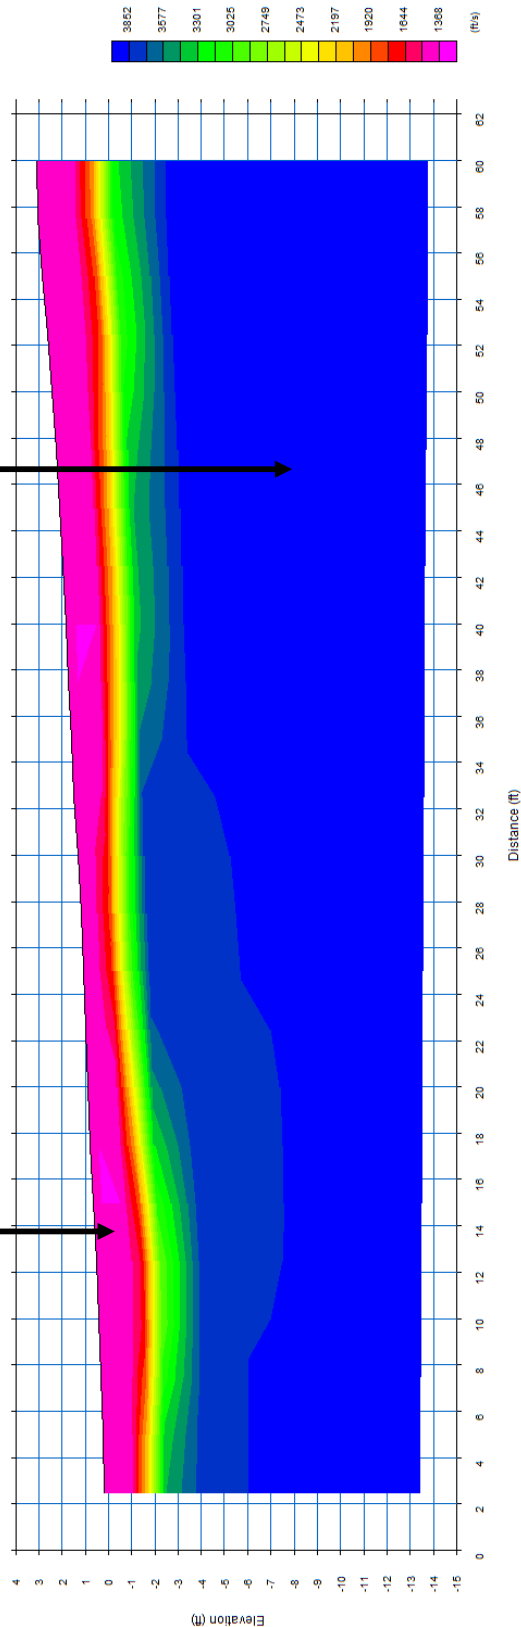
**Layer 2**

Granitic Rock; Very Highly to Highly Weathered  
Rock/Decomposed Granite, Possible Cementation  
and Dense Gravel and Cobbles  
Vp = 2500 - 5000 fps

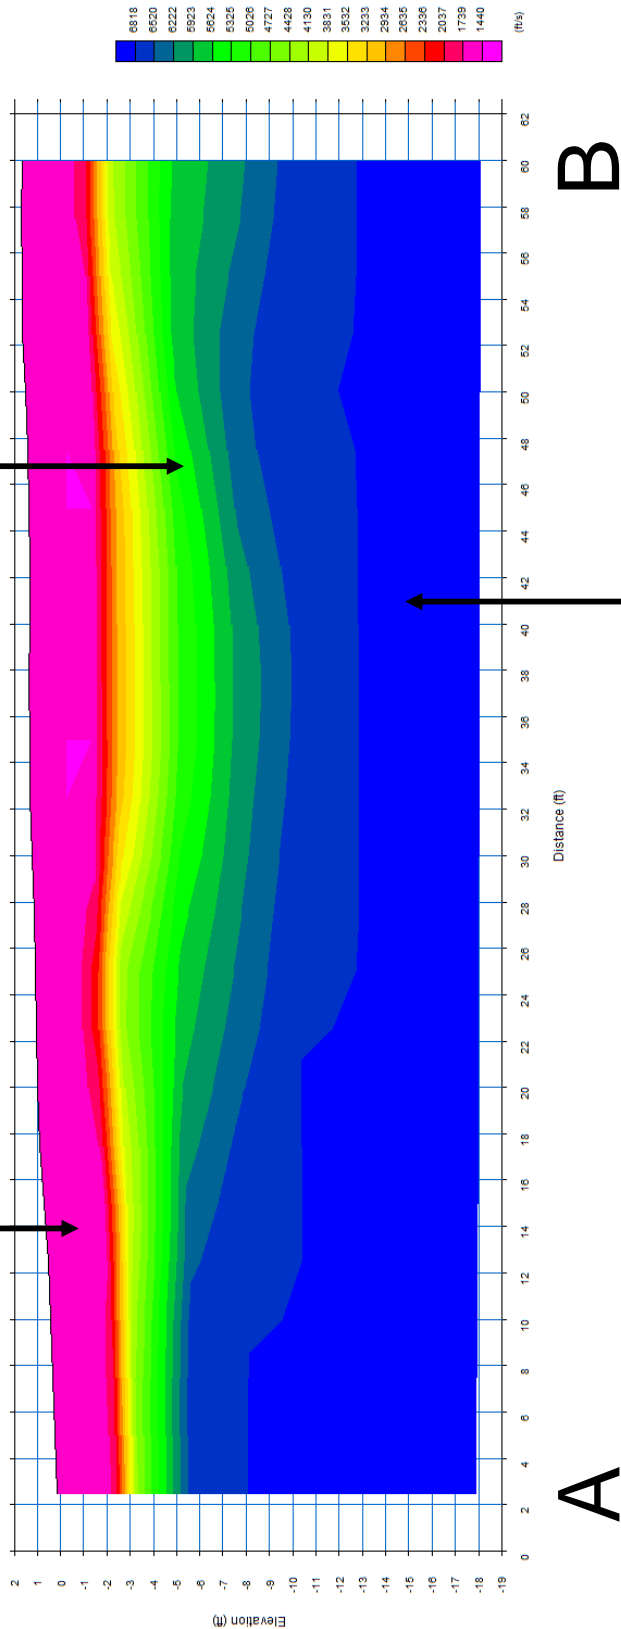
## Seismic Line #16

**Layer 3**  
 Granitic Rock; Moderately Weathered  
 Rock/Decomposed Granite  
 Vp = 5000 - 8000 fps

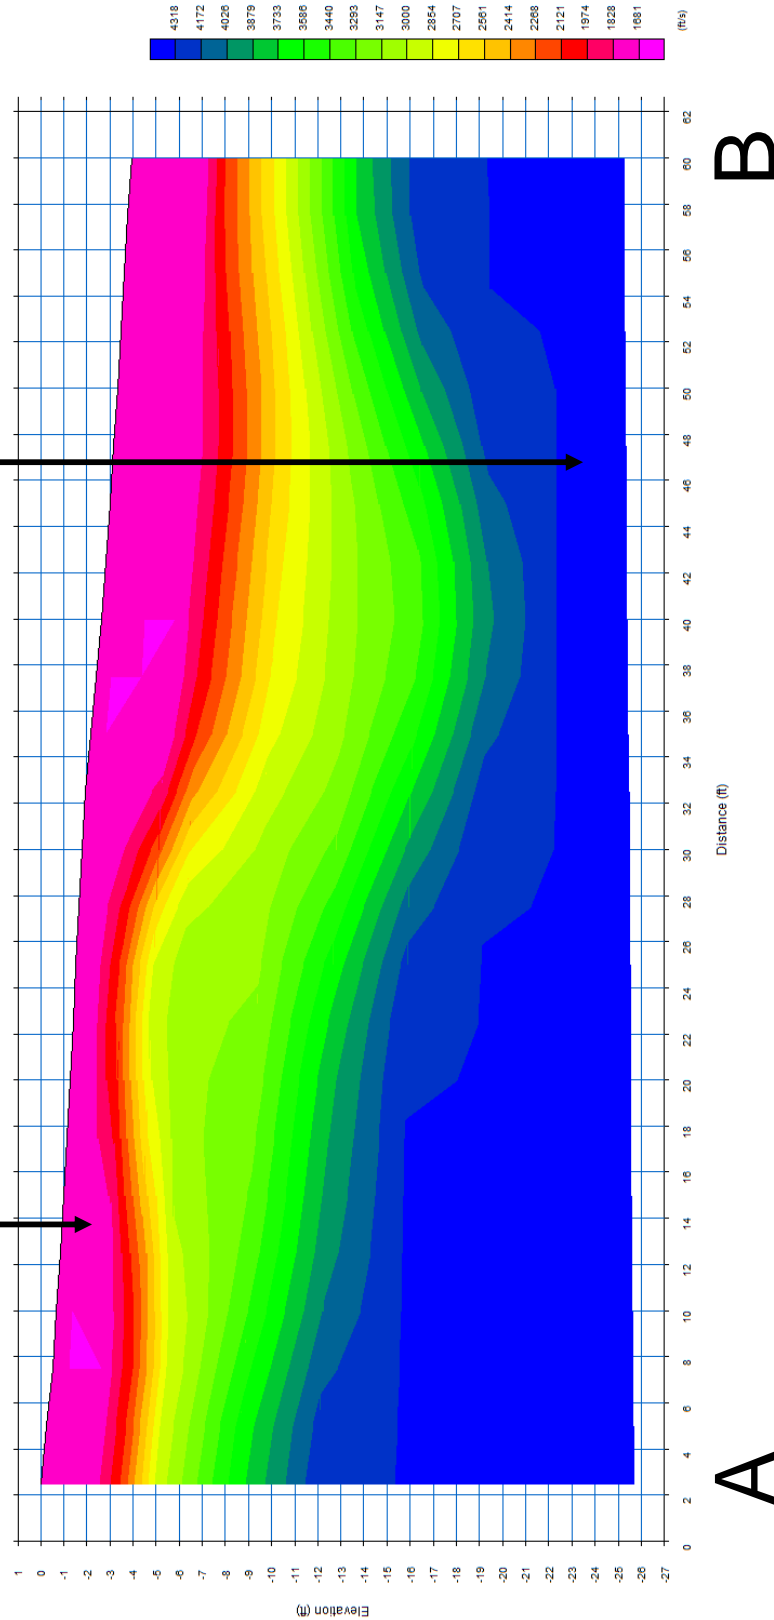
## Seismic Line #17

Surficial Layer of Silty Sand and  
Clayey Sand Soils with Varying  
Amounts of Gravel  
Vp = 1000 - 2500 fps

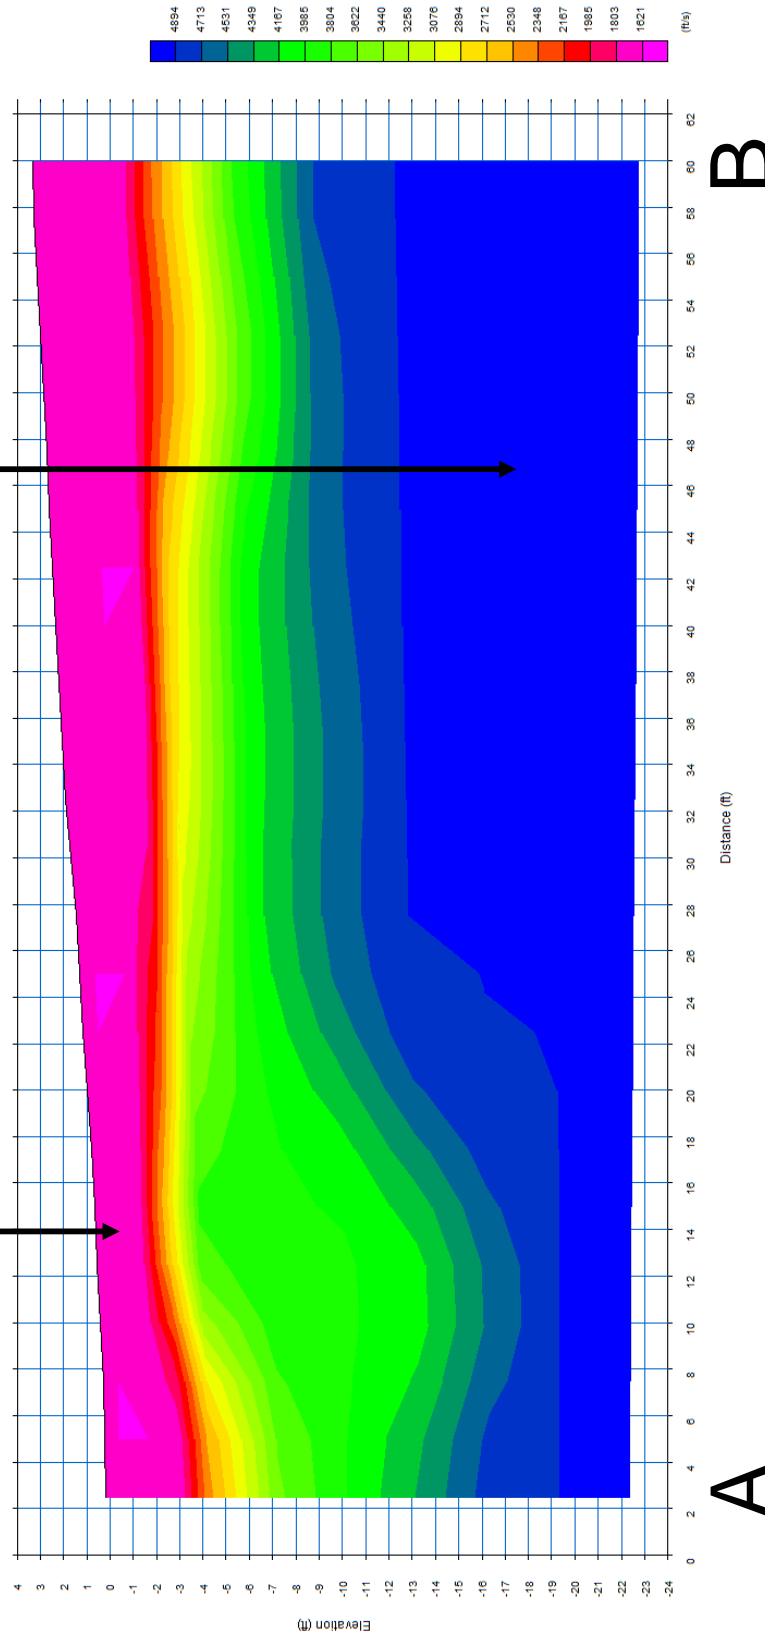
## Seismic Line #18

Granitic Rock; Very Highly to Highly Weathered  
Rock/Decomposed Granite, Possible Cementation  
and Dense Gravel and Cobbles  
Vp = 2500 - 5000 fps

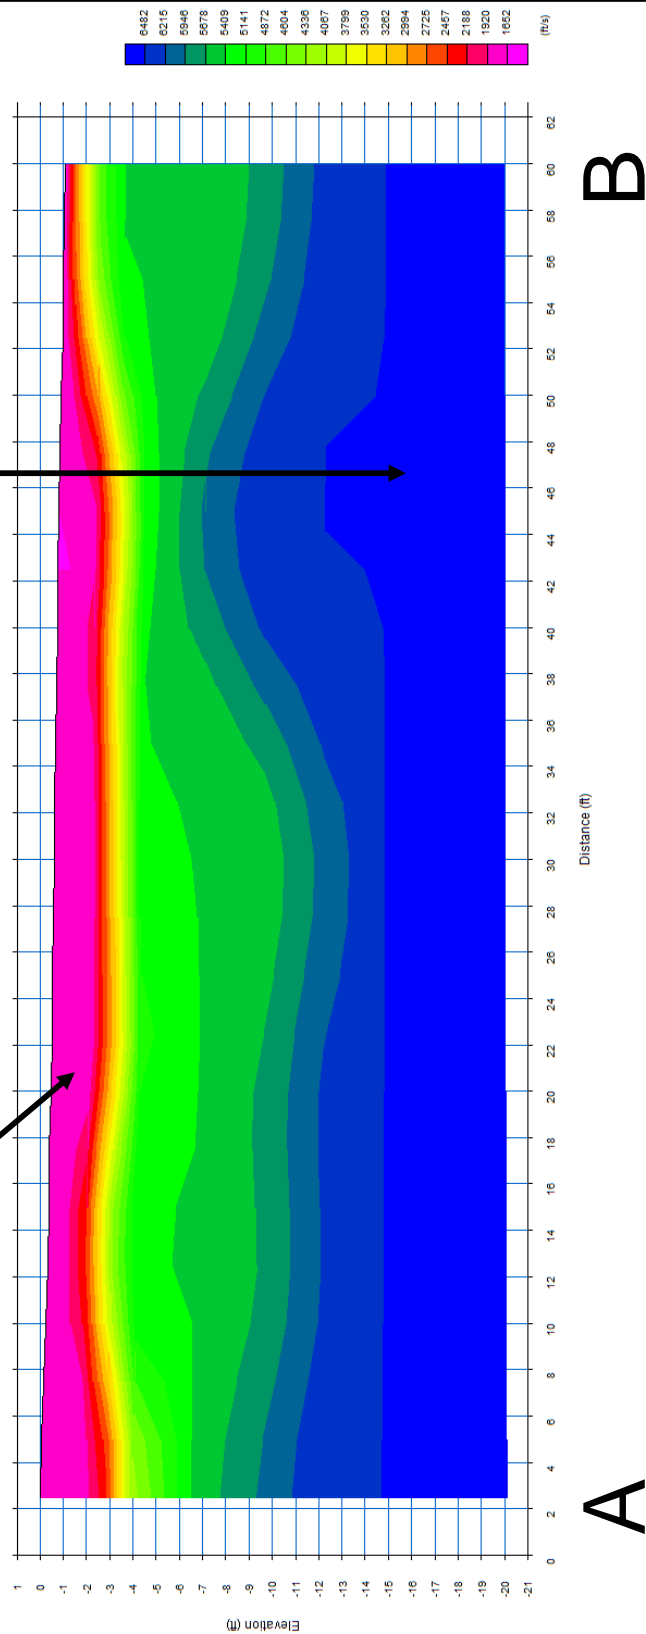
## Seismic Line #19

**Layer 1**  
 Surficial Layer of Silty Sand and  
 Clayey Sand Soils with Varying  
 Amounts of Gravel  
 Vp = 1000 - 2500 fps
